USAARL Report 76-21

REDUCTION OF GLARE FROM THE LANDING LIGHTS OF THE OH-58:
AN EVALUATION OF FOUR POTENTIAL SOLUTIONS

May 1976

US Army Aeromedical Research Laboratory
Fort Rucker, Alabama 36362

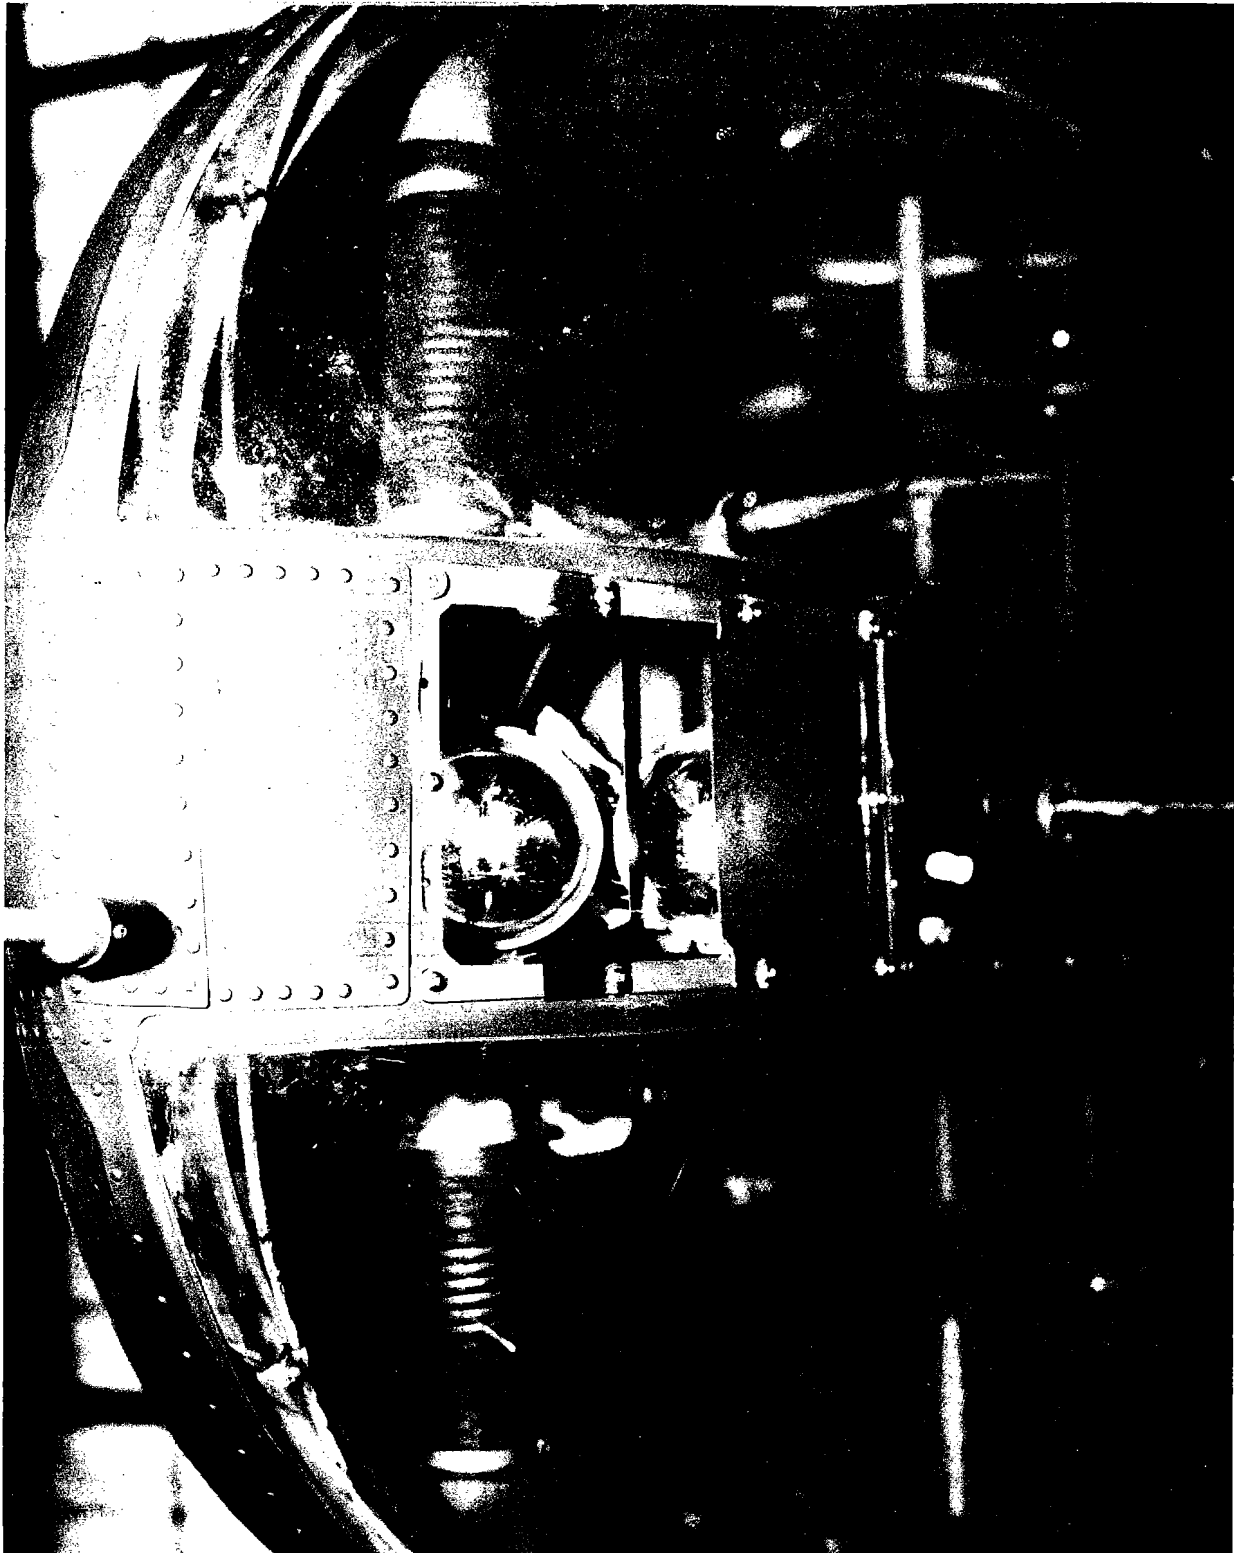
shields beneath the landing lights (Solution 1) since this involved no visibility loss or extra material inside the cockpit. However, the overheating of the plexiglass sheet over the light well caused by these metal shields will have to be overcome before this solution is acceptable. It was also found that the tape over the inside one-half of each chinbubble is a very good field-expedient "quick fix."

Solutions 1, 2, and 3 were all found to be very effective in reducing glare from the landing lights. The metal shield used in Solution 1, however, became so hot that it burned the protective plexiglass sheet covering the light well. Solution 2 involved a small amount of visibility loss. Solution 3 left a small streak of glare along the lower, outer edge of the ipsilateral windscreen and a large patch of glare in the center of the contralateral windscreen, i.e., the man in the left seat could see a small patch of glare along the lower, outer edge of the left windscreen and a larger glare patch in the center of the right windscreen. The situation was just the reverse for the man in the right seat. Figures 4 through 7 show the glare on the ipsilateral windscreen in the present configuration (no solution applied) and with Solutions 1, 2, and 3 applied. The white rectangles in the background are the runway markers and the windscreen glare is seen superimposed. Tables 1 through 4 show the photometric data for the present configuration and Solutions 1 through 3. It was concluded that if the overheating problem can be solved, Solution 1 together with the rewiring of the switch, is the preferred solution since it involves no visibility loss or additional material inside the cockpit. However, Solution 3 is a very good field-expedient "quick fix."

FIGURE 1. Solution 1 - Metal shield beneath the landing light.

Specifically, Solution 1 (Figure 1) consisted of placing a metal light shield under each landing light. Solution 2 (Figure 2) consisted of placing opaque light shields in the cockpit between the chinbubble and windscreen. These shields, one on each side, extended from the top of the instrument panel laterally and forward to the base of the windscreen. Solution 3 (Figure 3) consisted of taping over the inside one-half of each chinbubble which is the part of the chinbubble which transmits most of the offending light. Solution 4 (not shown) consisted of applying a one-inch wide strip of tape along the edges of the plexiglass sheet over the light well and taping over small holes in each side of the light well. All testing was done with the landing light switch rewired to OFF, FORWARD, and BOTH as described in both TB 43-0001-1-2, Equipment Improvement Report and the Maintenance Digest, April 1975. In this configuration, the second position (FORWARD) turns on the rear landing light (which points in a more forward direction) and the second position (BOTH) turns on both lights.

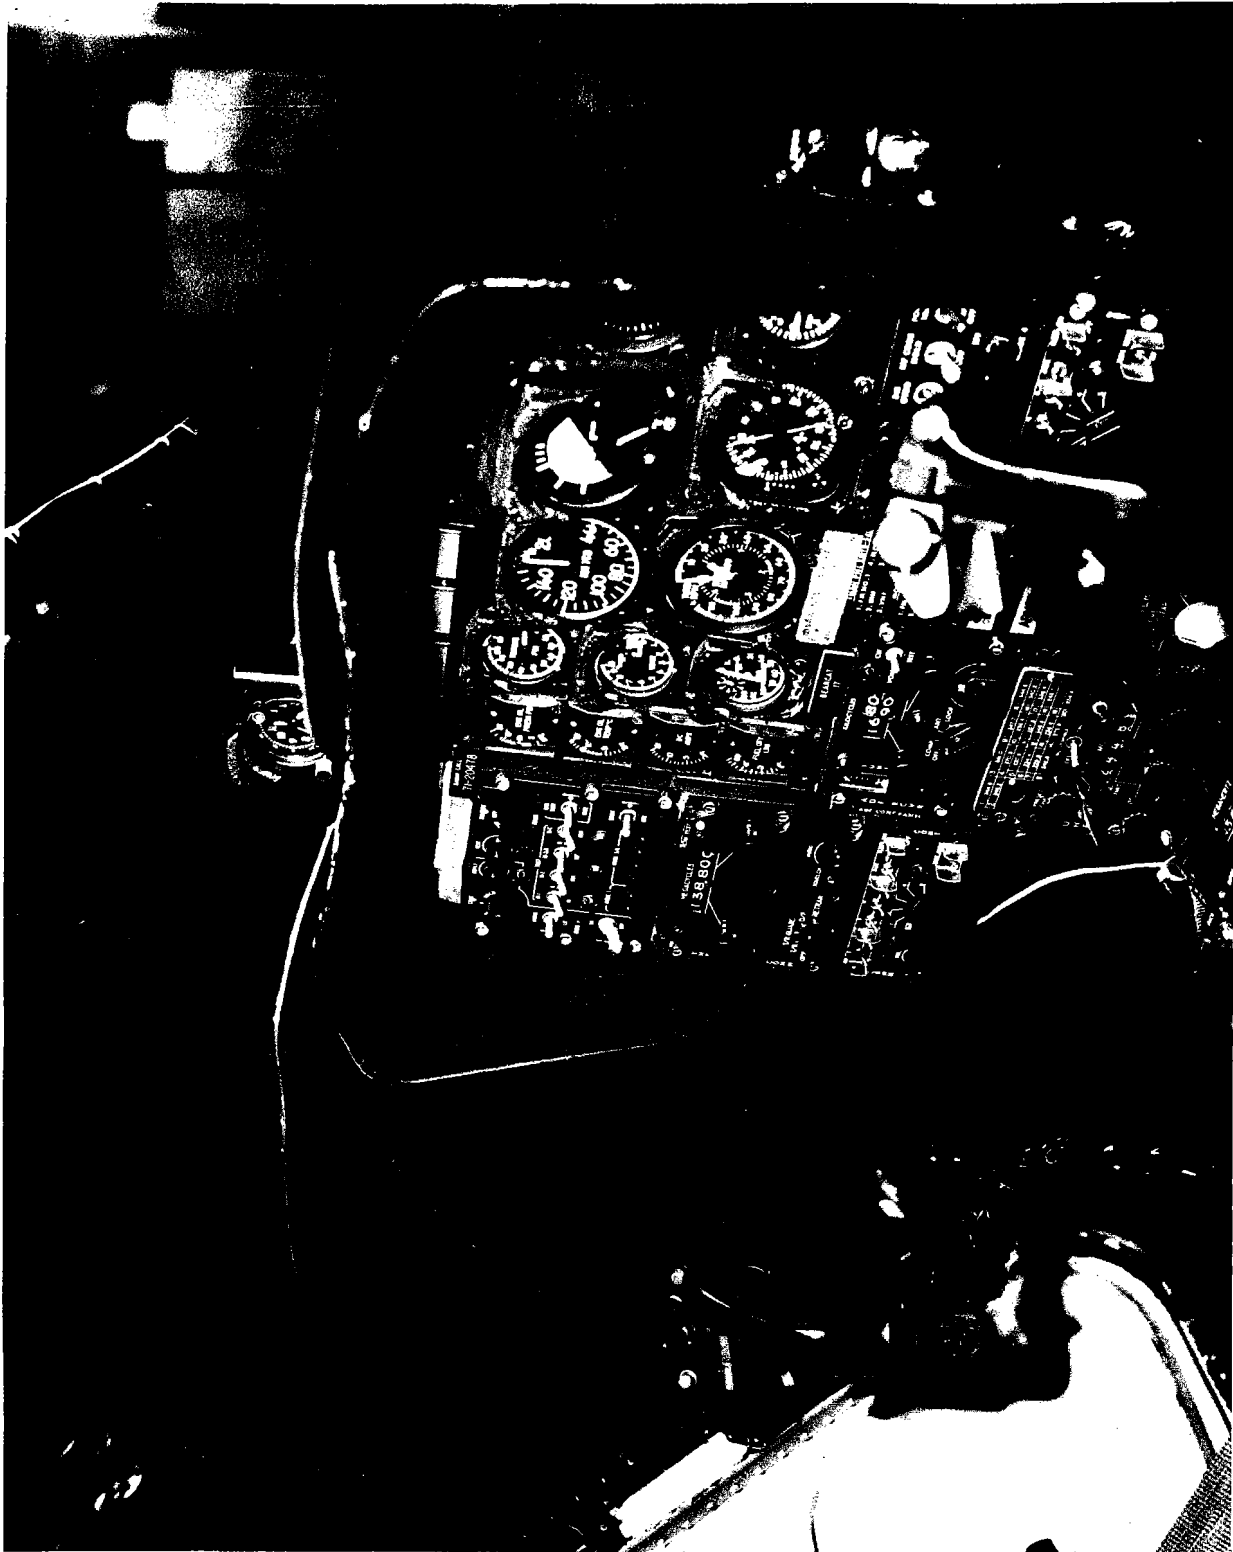
FIGURE 2. Solution 2 - Shields extending out laterally from the top of the instrument panel.
